TYPICAL PLAN

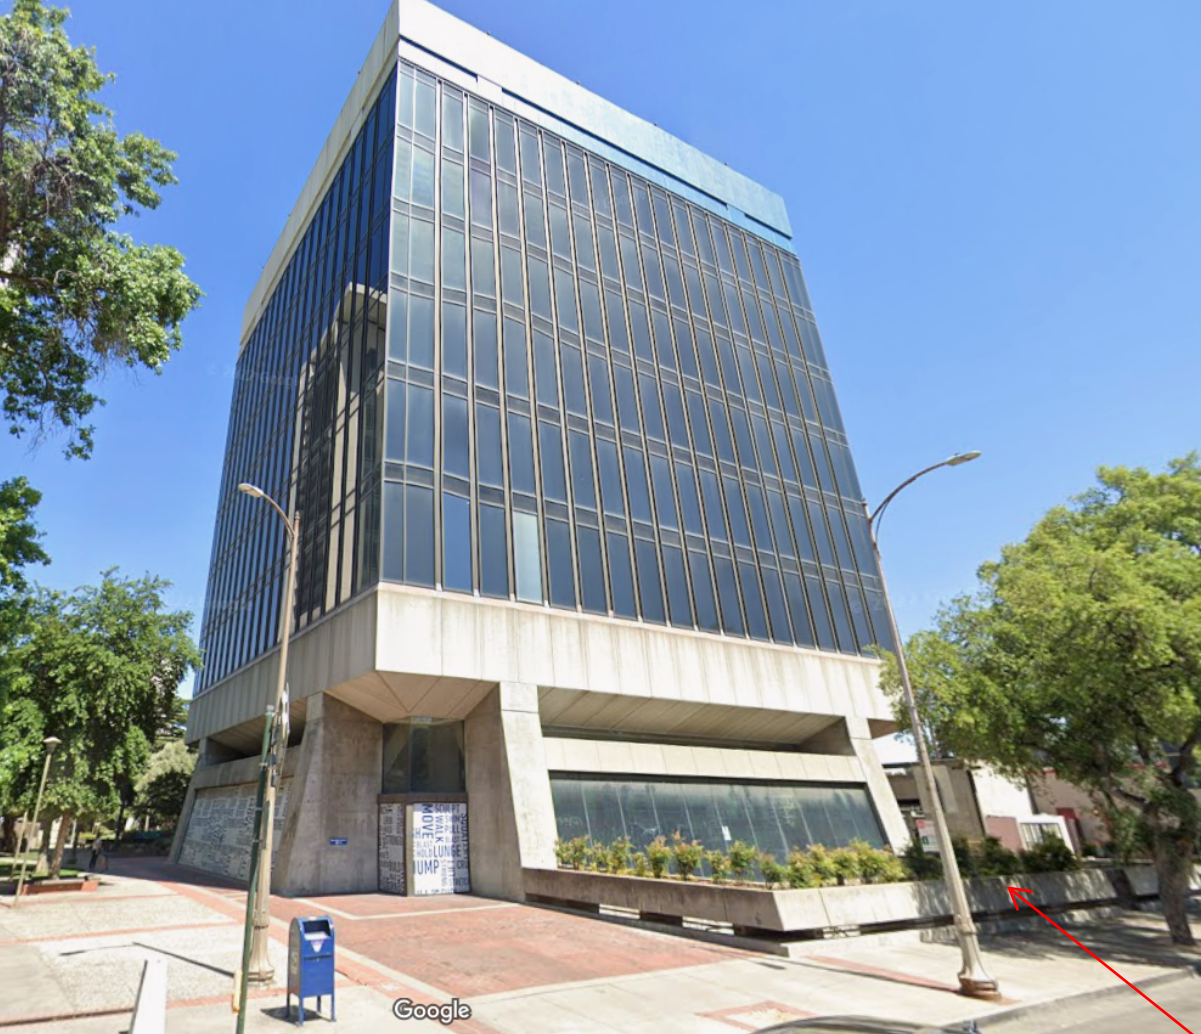
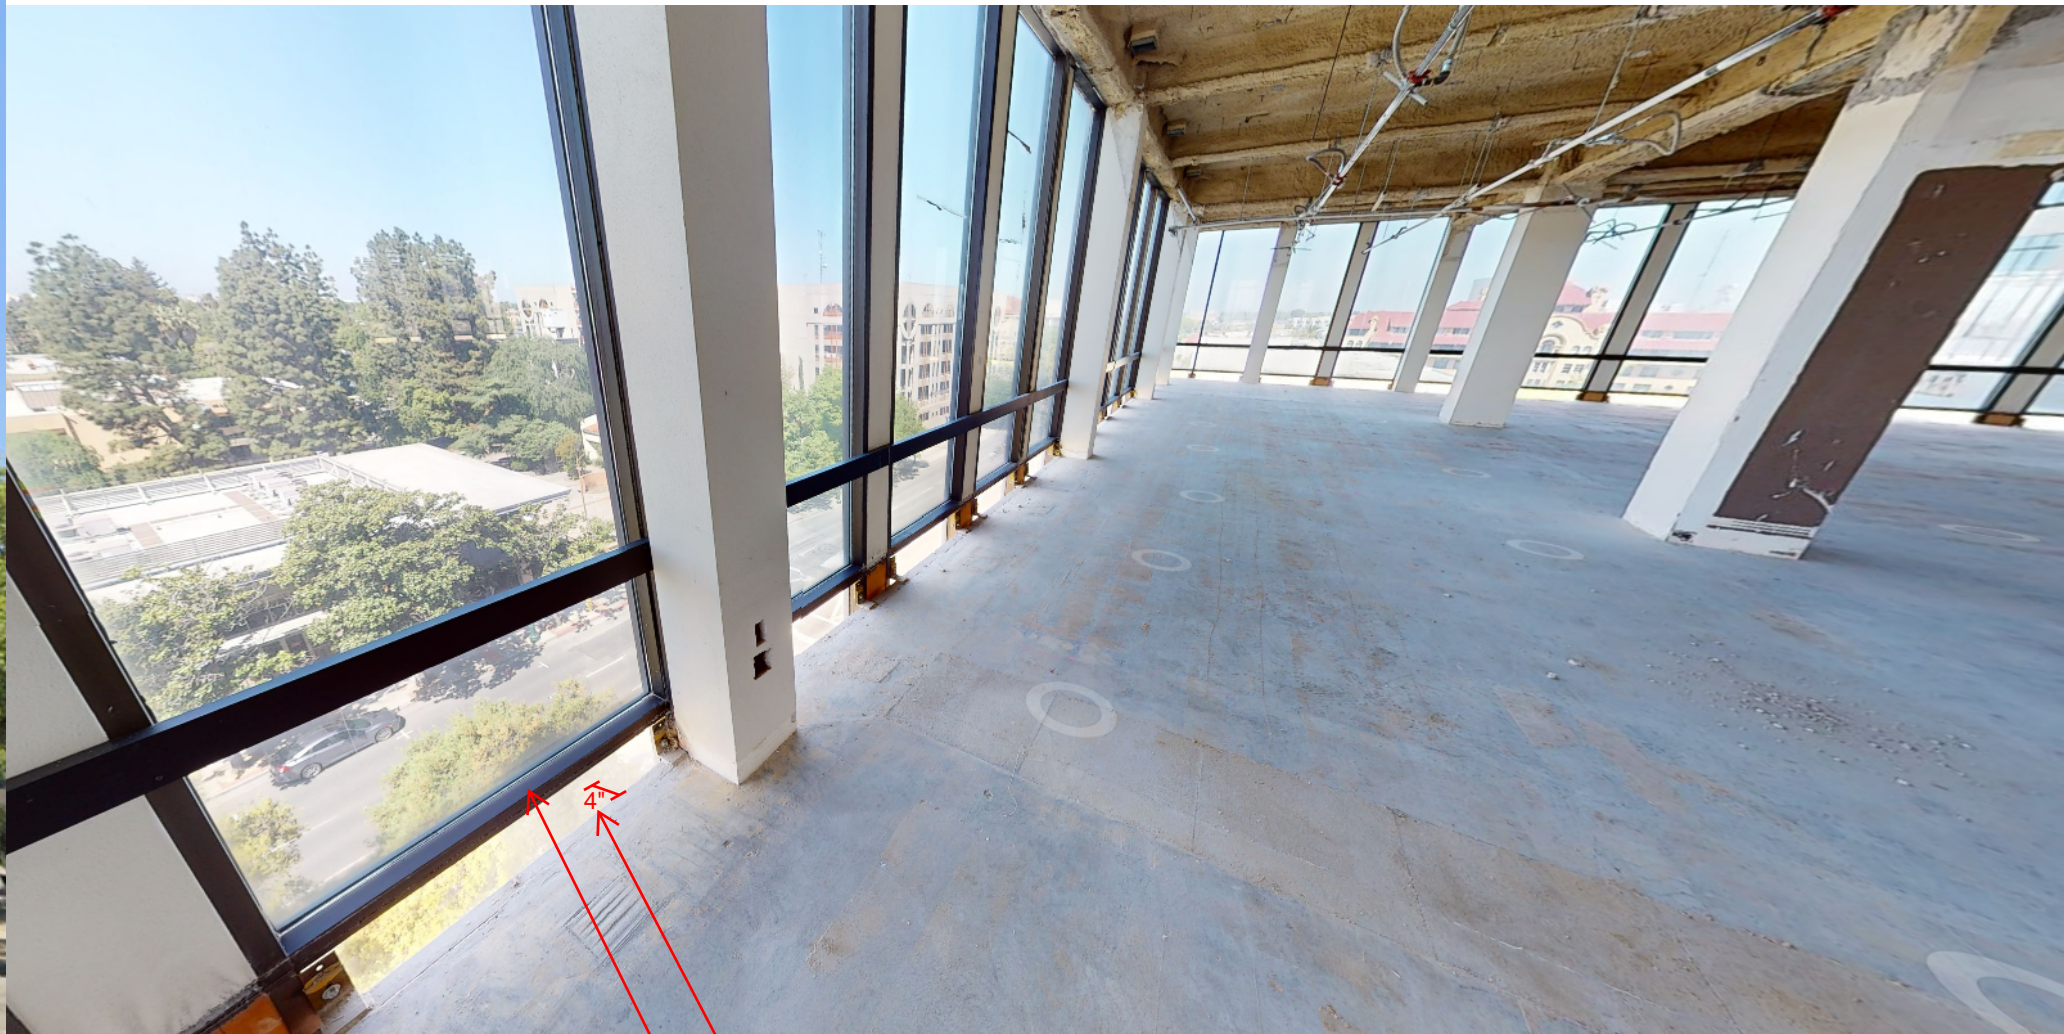
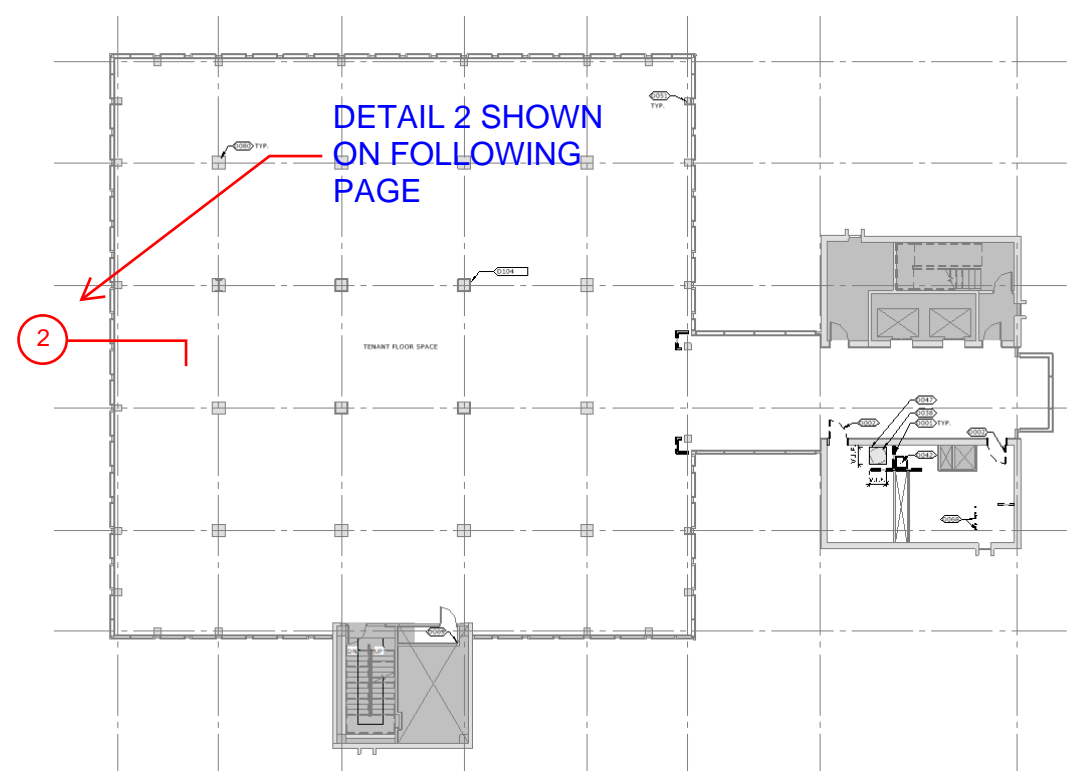
annealed glass and slab are separated by 4"

mullion sits 9" above slab

Glass spans from the 2nd floor to the 7th floor

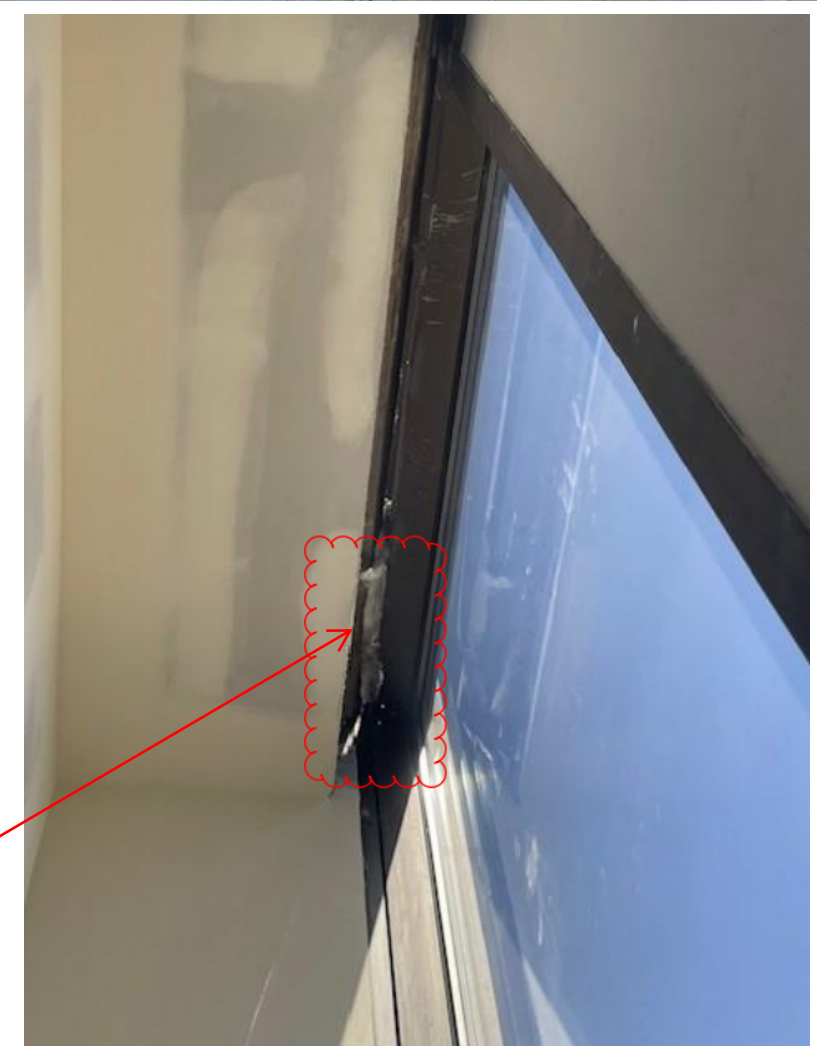
existing rockwool is falling from floors above.
