FIELD OBSERVATION REPORT

REPORT NUMBER F-71

PROJECT: 660 5th Ave (660 Fifth Ave)

REF#: 172 **Curtain Wall WT-3: General Assembly of Steel Framing**

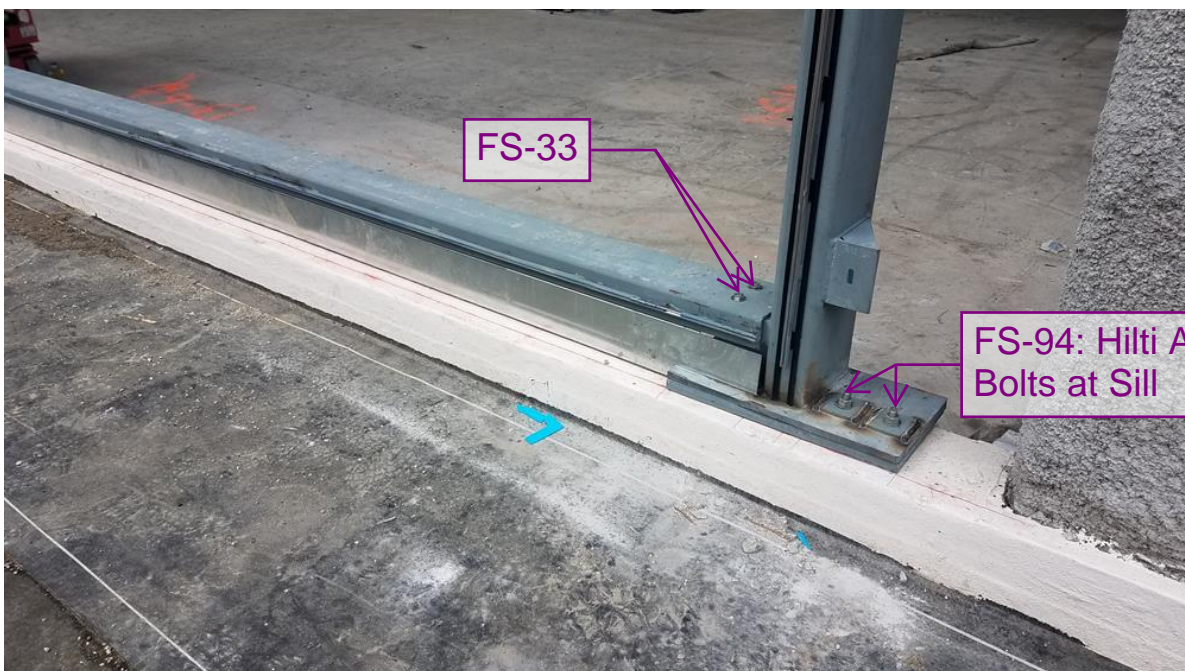
Photo 172.2 Overall view of the sill condition.

Socotec spot checked previously installed steel framing for WT-3 on the east elevation, 10th floor. Spot checks were performed from the ground level to confirm presence of slotted connection at the head, 5/8" thick sill plate (SS-02), Hilti bolt 5/8" diameter and 8-1/2" long (FS-94) installed at sill with welded flat washer, lock washer and nut, two bolts (FS-33) installed at horizontal structural steel to the vertical structural steel, and presence of vertical structural steel (ST-13). The work in progress was observed to be in general accordance with the approved as noted WT-3 shop drawings (submittal 084423-037-02), with the exception of the following:

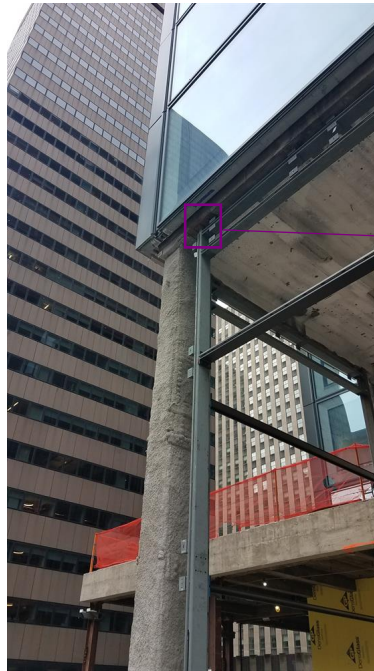
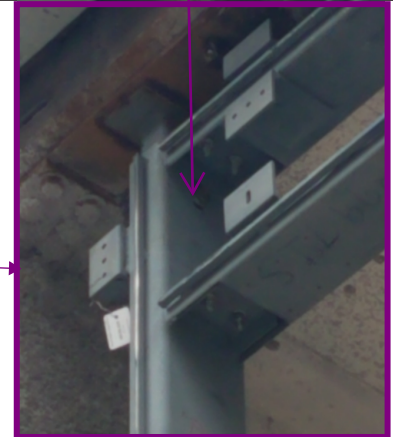
Photo 172.3 Overall view of the head condition.

Slotted Connection

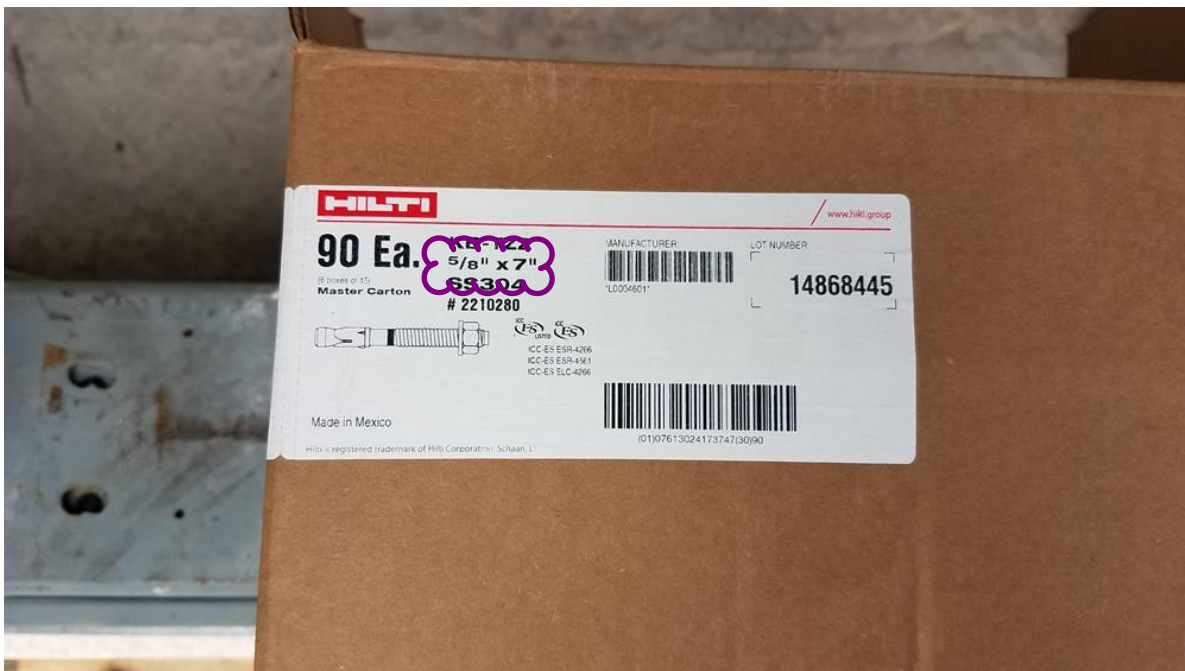
Photo 172.4 View of Hilti bolt at sill - 5/8" diameter x 7" length

1. WT-3 shop drawings (084423-037-02) and calculations (084423-040-00) are not signed and sealed by NYS PE. Island advised that they will be submitting updated shop drawing and calculations, signed and sealed by NYS PE. - OPEN
2. The shop drawing sheet EWS-552rev1, calls for fastener FS-94 at the sill. The fastener schedule calls for FS-94 to be 5/8" diameter and 8-1/2" long. However, in the field the bolt box noted the length of the bolt as 7" and when installed the embedment measured approximately 4". The calculations and shop drawings do not call out the required embedment. This was discussed with Island who advised that they will be submitted updated calculations that calls for 3-1/4" embedment. – OPEN
3. Two bolts on the south elevation were observed to be tilted. Island advised that this will be corrected in the field– OPEN

1. Island for formally submit WT-3 shop drawings and calculations, signed and sealed by NYS PE.
2. Island to formally submit the updated calculations, showing embedment, signed and sealed by NYS PE .
3. Island to remediate the observed screwed bolts per the approved shop drawings. Turner to advise when the work is complete for Socotec's reinspection.
