Villa San Bernardo Motherhouse

Issue: PERMIT & BID SET
Date: 02/02/2017
Project Number: 14-063

FLOOR SECTIONS

Sheet Number:
S3.2

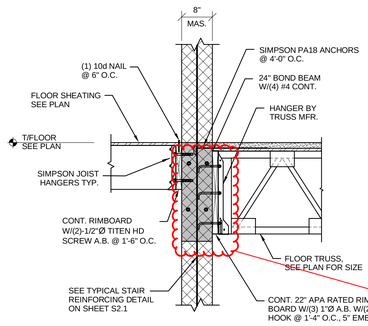
SECTION 9
SCALE: 3/4" = 1'-0"

These A Bolts were no poured into the bond beam. Is there an adhesive anchor equivalent?
